ENVIRONMENTAL SURVEY REPORT
ASBESTOS, PCB, LEAD BASED PAINT AND RADON SURVEY
88TH Regional Support Command
MILWAUKEE (LOGAN), WI (WI-042)
USARC AND OMS
2373 SOUTH LOGAN AVENUE
MILWAUKEE, WI 53207

Adecco Technical Task Order DAY A000003029

Gil Bakshi, MA
President
05 October, 2005

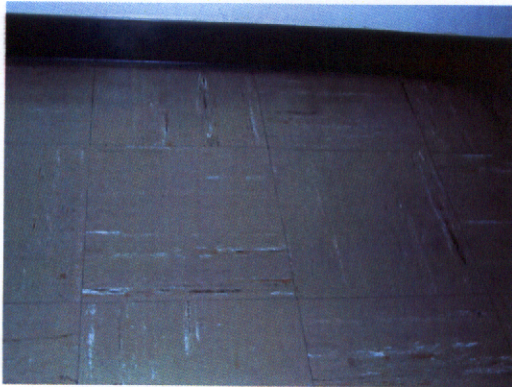
12" x 12" Beige floor tile (VFT-1)
(tile and mastic contains asbestos)
